USAAVLABS TECHNICAL REPORT 68-51

AN EVALUATION OF ARMORED AIRCREW CRASH SURVIVAL SEATS

July 1968

**CONTRACT DAAJO2-68-C-0027
DYNAMIC SCIENCE
DIVISION OF MARSHALL INDUSTRIES
PHOENIX, ARIZONA**

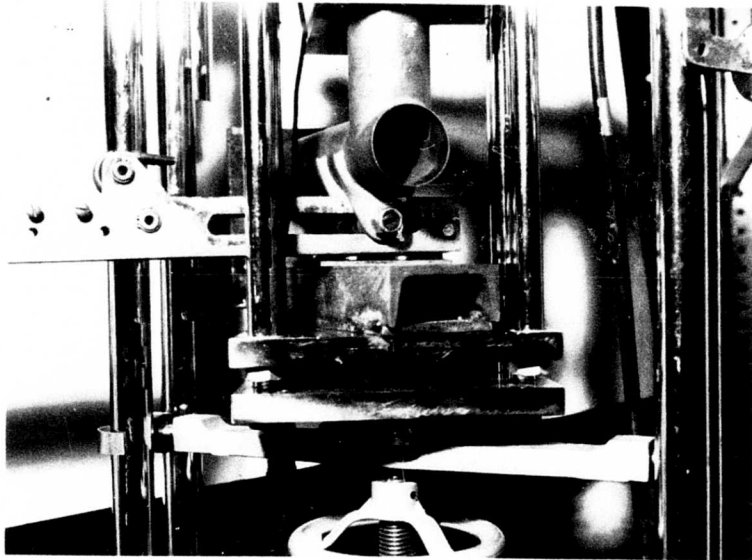
In the first of these static tests, a sample forward support tube/lower cross tube joint was fabricated using parts from the failed seat. This joint was fabricated according to Hayes International Corporation Drawing No. 201-00003. The completed joint was mounted in a Dillon Testing Machine, and a compressive load of 10,000 pounds was applied. Figure 9 shows the joint just prior to testing. The only failure noted was that of the seat roller, which failed at 10,000 pounds.

Figure 9. Support Tube Joint Installed in Testing Machine.

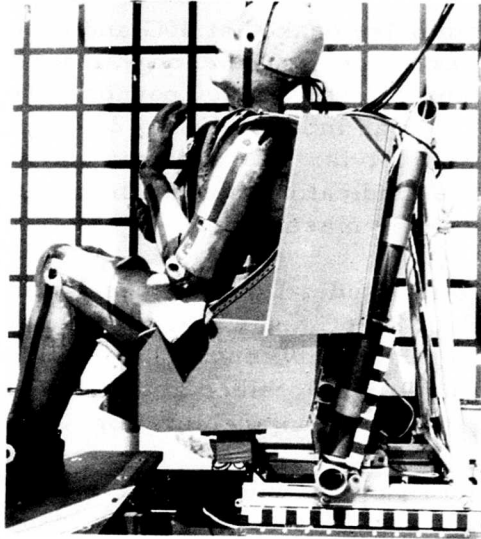
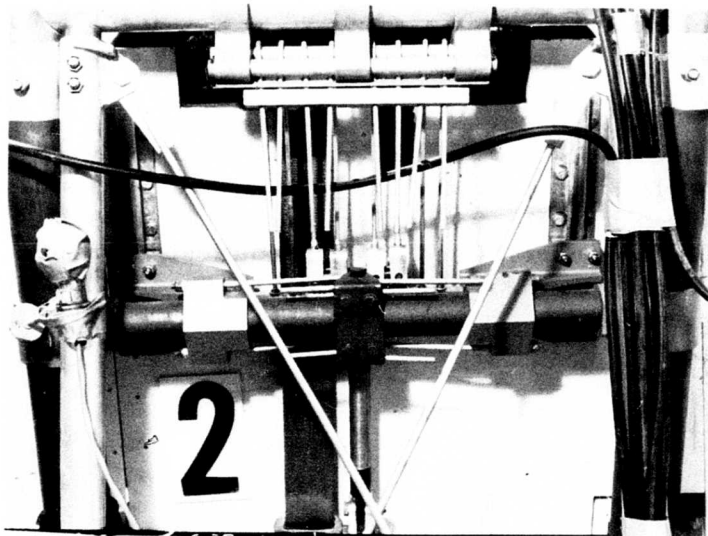
Figures 19 and 20 show posttest views of the seat and energy absorbers. All eight energy absorber rods were used, in accordance with the requirements given in Table II for an armored seat with a 200-pound occupant.

Figure 19. Posttest Side View - Test 2.

Figure 20. Energy Absorbers After Test 2.

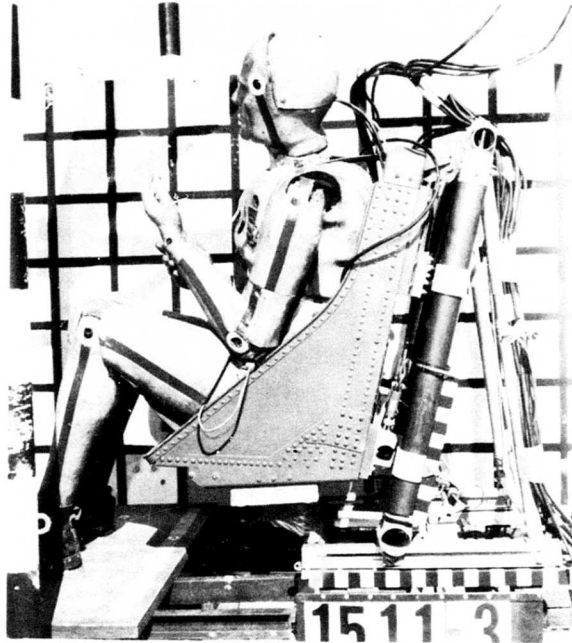
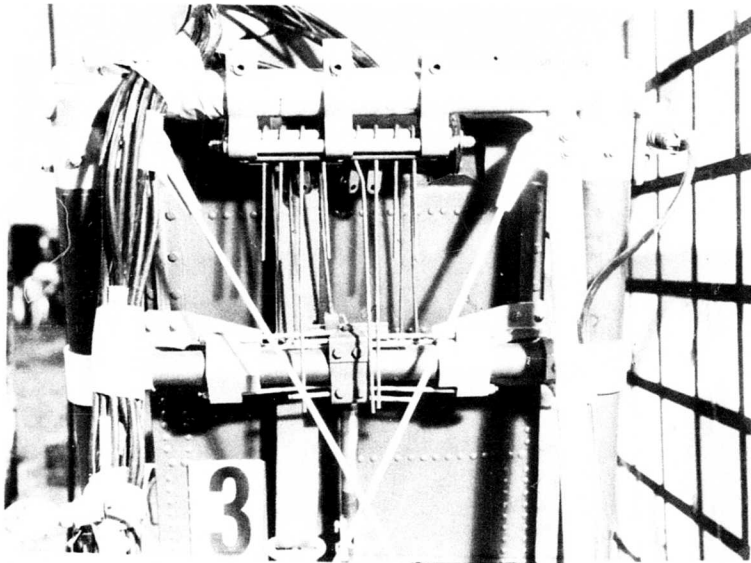
Figures 23 and 24 show posttest views of the seat and energy absorbers. Five energy absorber rods were used, in accordance with the requirements in Table II for an unarmored seat with a 200-pound occupant.

Figure 23. Posttest View of
Seat - Test 3.

Figure 24. Posttest View of Energy
Absorbers - Test 3.

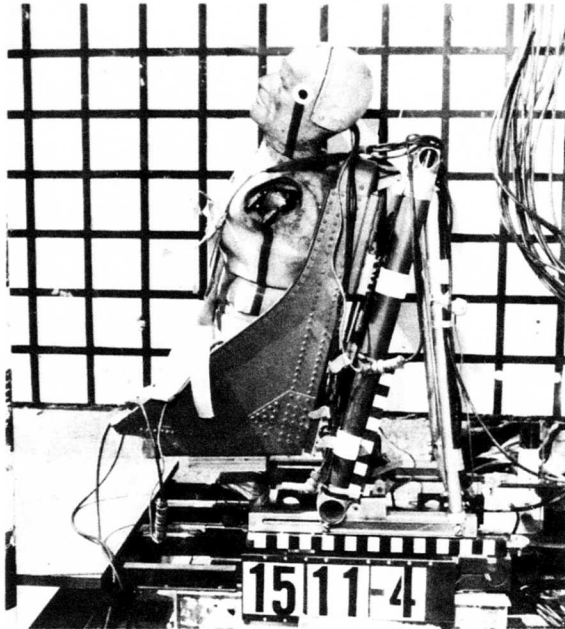
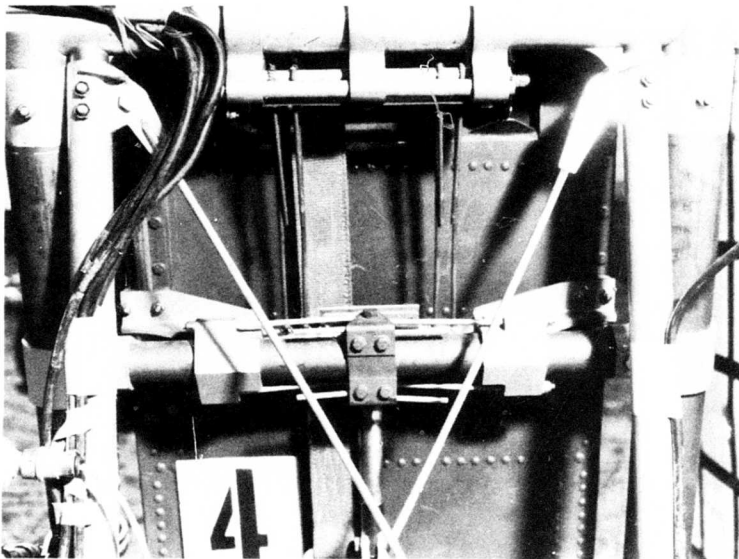
The input acceleration pulse peaked at 41.2G and produced a velocity change of 39.8 feet per second. The energy absorbers stroked 6.87 inches and reduced accelerations from the 41G input to 30.5G at the occupant's pelvis. Figures 27 and 28 show posttest views of the seat and energy absorbers. Four energy absorber rods were used, in accordance with the requirements in Table II for an unarmored seat with a 135-pound occupant.

Figure 27. Posttest View of
Seat - Test 4.

Figure 28. Posttest View of Energy
Absorbers - Test 4.

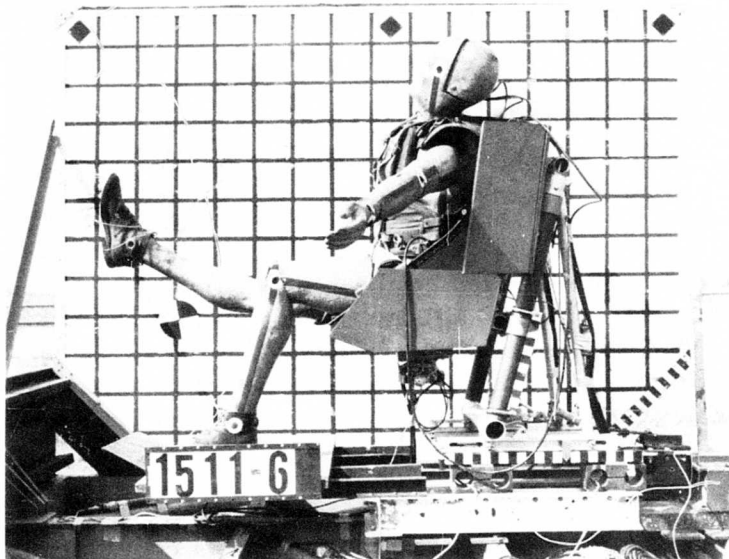
Premature crushing of one of the safety pads resulted in a pulse with a peak of 21G and a velocity change of 43.2 feet per second. Figure 30 shows a posttest view of the seat.

Figure 30. Posttest View of Seat - Test 6.

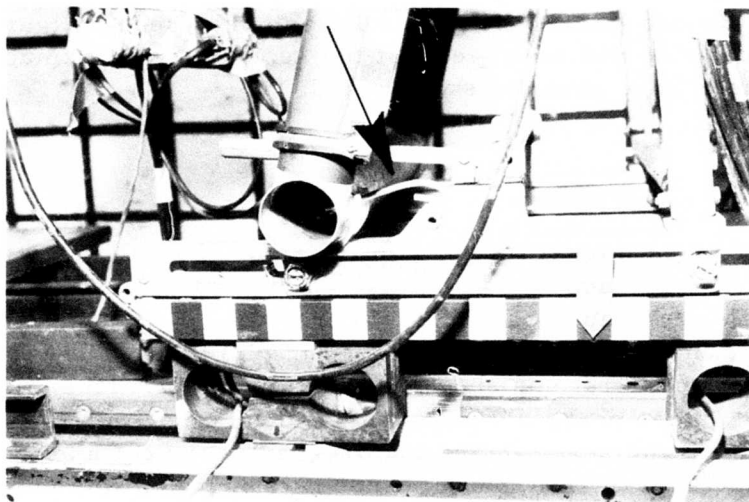
The energy absorbers stroked 2.18 inches. The left outboard energy absorber rod failed at the weld joining the threaded attachment end to the rod. Examination of the high-speed film and electronic data indicated that this failure occurred early in the loading cycle. This failure probably limited deflection by allowing the left side of the seat to move ahead of the right side, thus binding the seat on the slides. High-speed film coverage shows the left side moving ahead of the right side and substantial twisting of the seat frame. Further evidence of this binding is the fact that the left front and right rear seat rollers failed. Figures 31 and 32 show posttest views of the left and right energy absorbers, respectively.

Figure 31. Posttest View of Left Energy Absorber - Test 6.

4. The weldment that joins the longitudinal energy absorber rods to the threaded attachment fittings fails at loads below that required to stroke the rod.

The performance of the bending rod energy absorber design during the dynamic loading condition cannot be completely evaluated, as one of the four rods failed during the stroke. As a result of this failure, the left side of the seat moved ahead of the right side and caused the seat track to bind. This energy absorber failure at the weld between the rod and the seat attachment was also observed in the static test of the seat. It is apparent that either the design of the rod must be changed or better welding procedures combined with good quality control must be assured before this design is tested further.

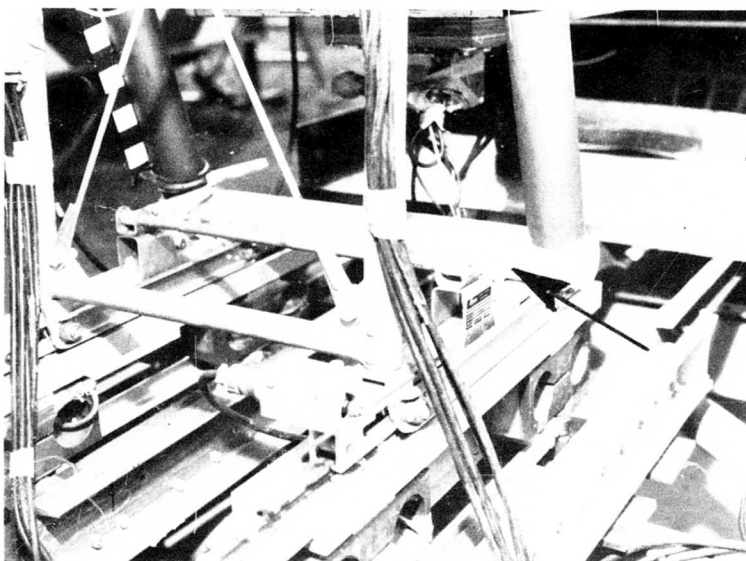
Figure 32. Posttest View of Right Energy Absorber - Test 6.

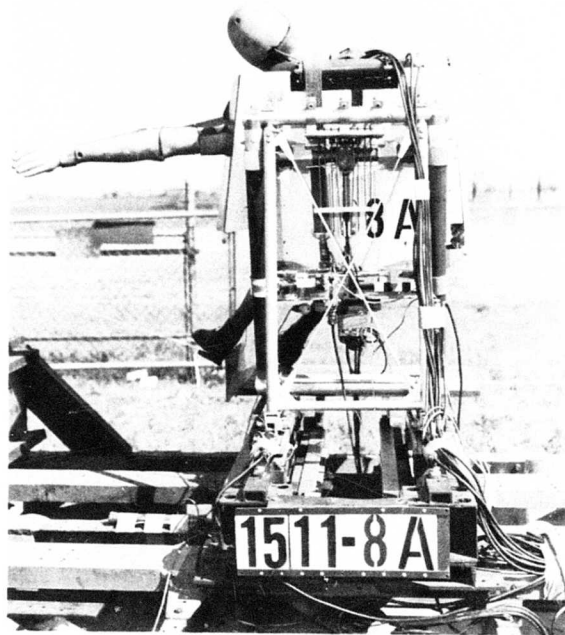
No seat damage or stroking of the energy absorbers occurred in this test, although the seat-pan and occupant pelvic accelerations peaked at 33.5G and 65G, respectively.

Figure 35. Posttest View of Seat -
Test 8A.

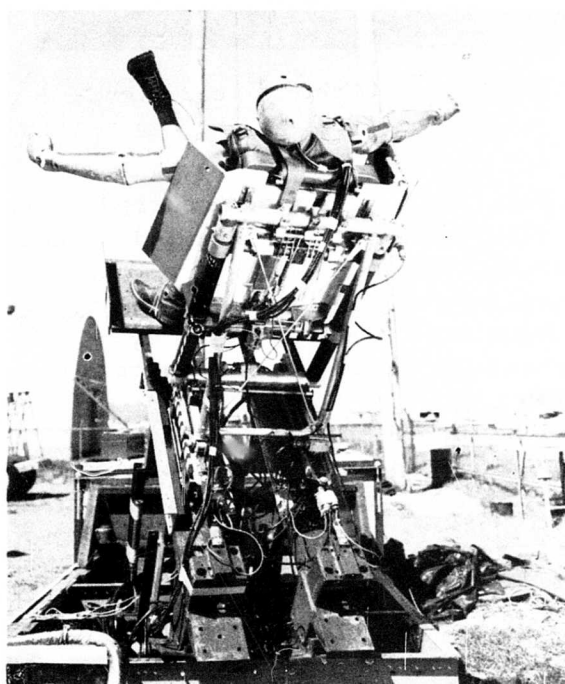
of 46.2 feet per second. No seat damage occurred. The vertical energy absorber stroked 2.72 inches, while the longitudinal and lateral energy absorbers did not stroke. The high seat-pan and occupant pelvic accelerations in the vertical axis reflect the limited energy absorber travel. These vertical accelerations were approximately in phase with the vertical input pulse, particularly during the early part of the pulse.

The reversal in the longitudinal seat-pan acceleration was probably caused by the release of a rear tiedown bolt on the seat mount. At the peak of the input pulse this bolt came free, allowing the seat mount to flex upward and forward.

Figure 39. Posttest Rear View - Test 9.

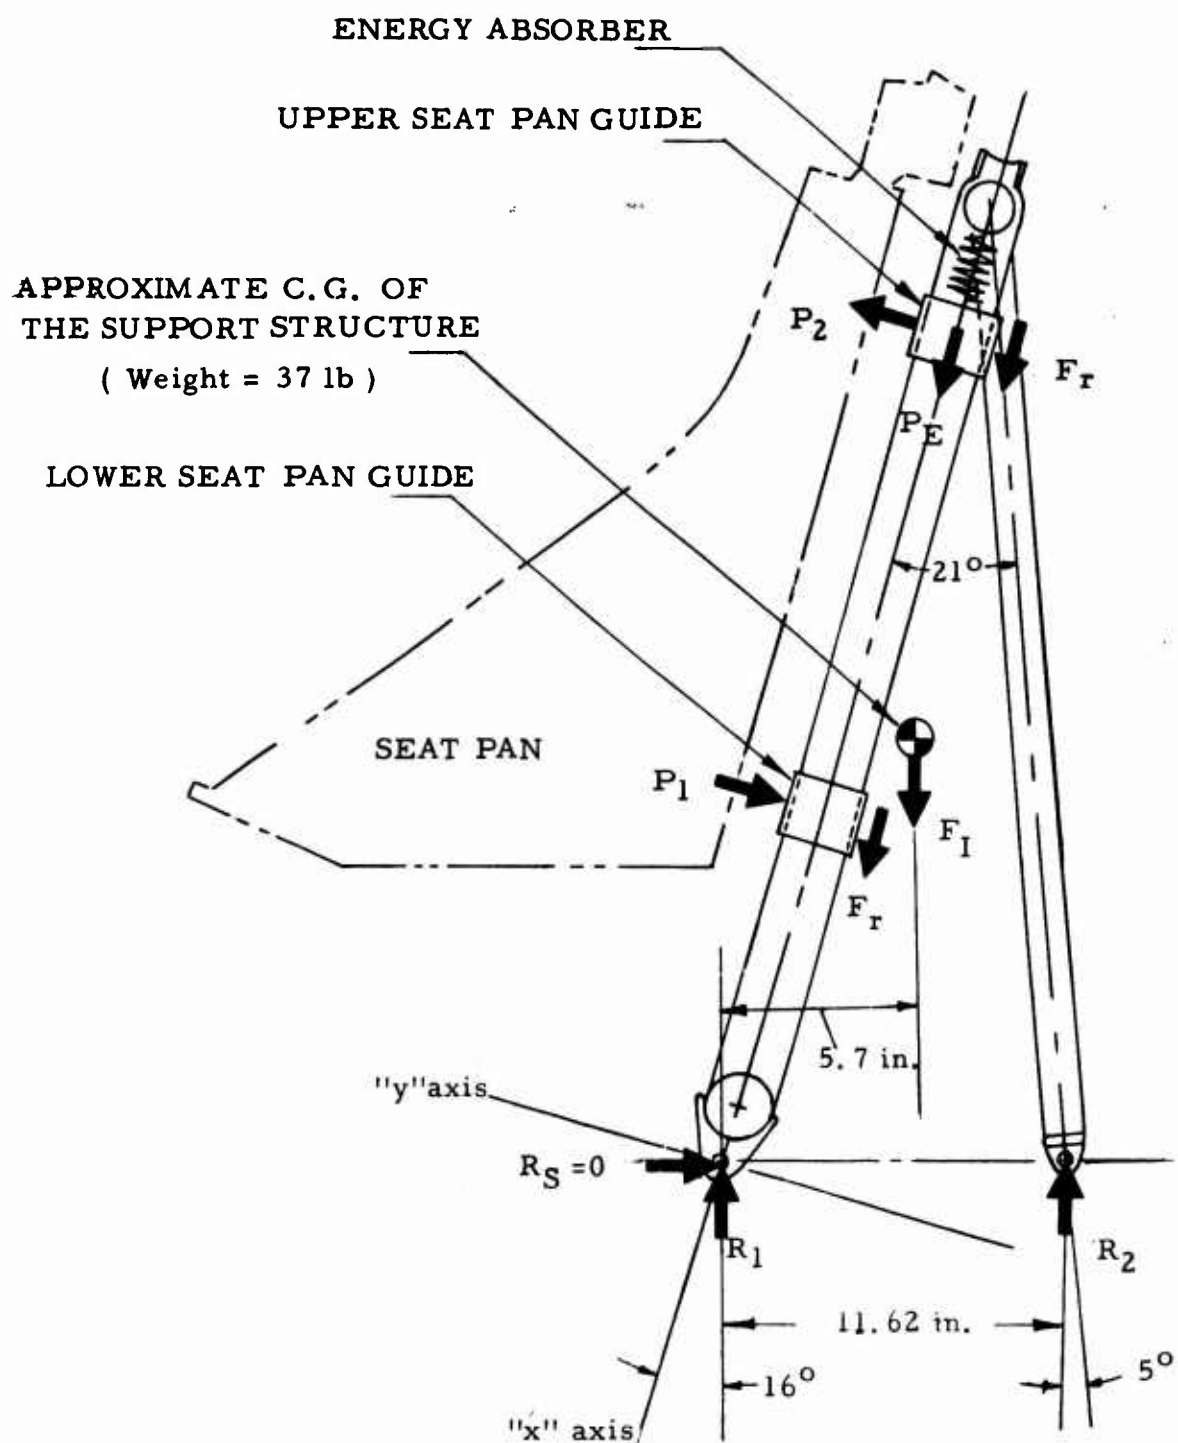
The occupant pelvic acceleration that should have resulted from this energy absorber load is 16G. However, a peak of 27G in the occupant's pelvis and 25G on the movable portion of the seat pan were recorded at the same time after impact as the 4,700-pound energy absorber load. This can only mean that an additional force was applied to the seat pan other than that applied through the energy absorber. Investigation of the possible sources of this additional force revealed that large friction forces (F_r) may exist between the front tubes of the seat support structure and the seat pan guides, as shown in Figure 40.

Figure 40 shows the eight typical forces that may be applied to the seat support structure in a vertical impact. These include the total seat reaction loads on the floor (R_S , R_1 and R_2), the seat inertia load (F_I), the seat-pan guide loads (P_1 , P_2), the guide frictional load (F_r), and the energy absorber load P_E . The load R_S is effectively zero for pure vertical drops along the "x" axis. Summing the forces along the longitudinal axis of the front support tube in Figure 40 gives

Figure 40. Free-Body Diagram of the Seat Support Structure.

It should be noted that the peak friction force (4,200 pounds) is almost equal to the peak energy absorber load (4,700 pounds). As a result, the load being applied to the seat pan is almost double that of the desired load. Obviously, a suitable means must be found to eliminate this variable friction force. One solution would be the use of linear bearings or rollers in the guide system. In fact, one of the four original seat designs referred to in the Introduction of this report used a roller guide system. Caution must be exercised on the part of the seat designers to

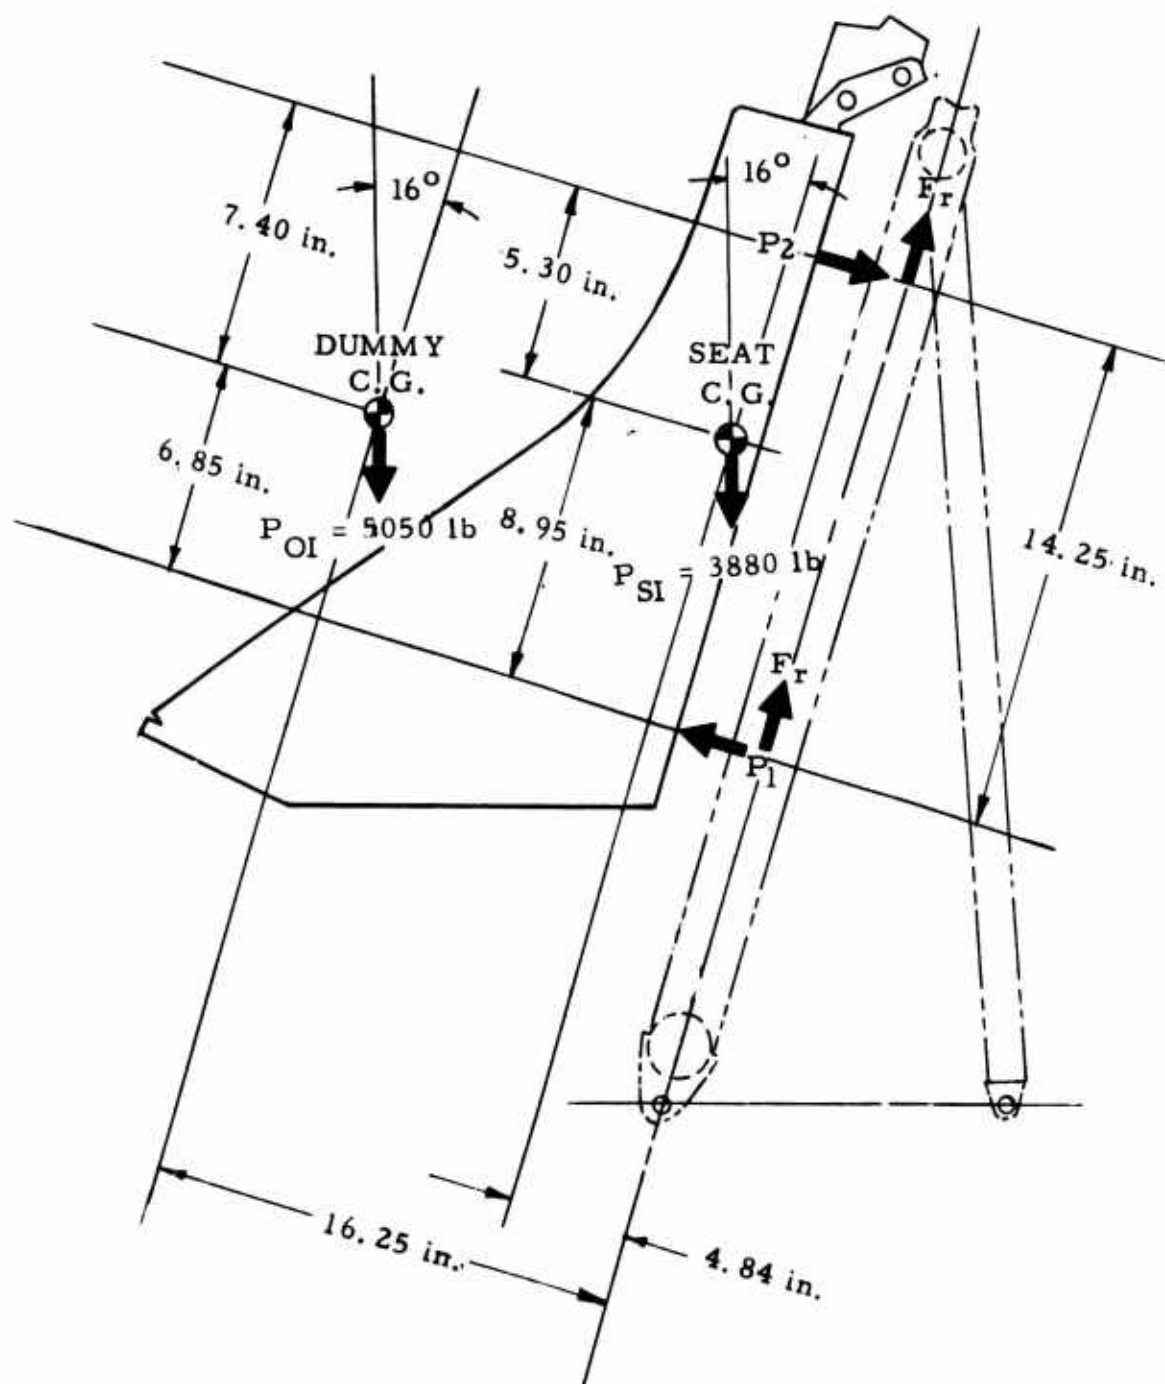
cannot be fully resolved. However, if it is assumed that the seat pan (155 pounds) is decelerating at the peak value of 25G and that the effective body mass (173 pounds) and the body armor (14 pounds) are decelerating at the maximum pelvic rate of 27G, then the seat inertia and occupant inertia loads P_{SI} and P_{OI} in Figure 42 are 3,880 and 5,050 pounds, respectively.

This does not appear to be an excessively high coefficient, particularly if dust or other foreign material is present. In fact, the measured coefficient on one of the four seats was found to be 0.45 with 145 pounds of normal load applied and 0.30 with 310 pounds of normal load applied. It may thus be considered reasonable that dry friction is present in this seat design since the calculated 4,200-pound frictional load results.

Figure 42. Free-Body Diagram of the Seat Pan.

make certain that the movable part of the energy absorbing seat system not only is free of friction but strokes smoothly without variable resistance. This must occur when the seat is subjected to all anticipated loads, even though distortion of the seat pan guide system occurs. Such distortion occurs in the form of bending of the guide rails and torsion and shearing deformations due to lateral loads and floor buckling. Close-fitting seat-pan guide systems (as in the Hayes seat tested in this project) should be expected to bind and/or experience excessive frictional forces when subjected to these loading conditions.

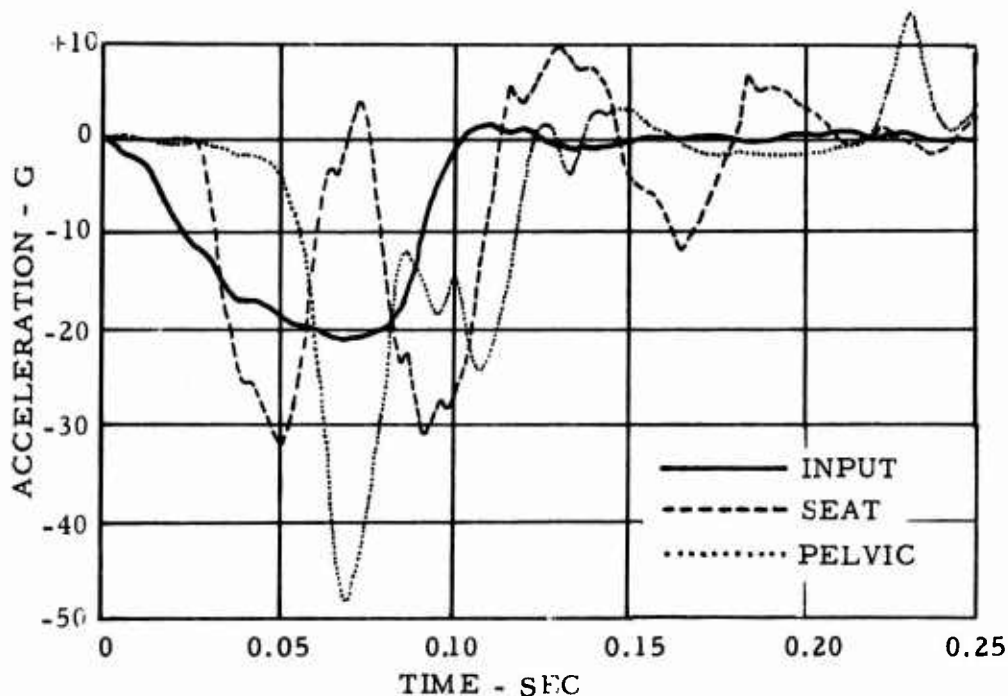
A detailed examination of the acceleration and force data recorded during the test indicates that the energy absorber might not have functioned as designed in this test, even if the energy-absorber had not failed. The forward deflection of the occupant, although small in comparison to tests of other seats, was sufficient to allow the dummy inertia force to lag the seat inertia force by 0.02 second, as shown in Figure 43. This resulted in a high pelvic acceleration of 48G peak at 0.07 second. This acceleration level is at the upper limit of human tolerance; even more important, the high rate of onset of 2500G per second is considered to be excessive from a human tolerance standpoint. Methods of insuring that the seat and occupant inertia forces act more in phase with each other must be investigated before proper operation of the longitudinal energy absorber can be expected.

Figure 43. Composite Acceleration Data Overlay - Test 6.
